November 4, 2014

Re: Horse Farm, Livestock Office, and Horticulture Shed Cost Evaluation Report,
Revised to address comments

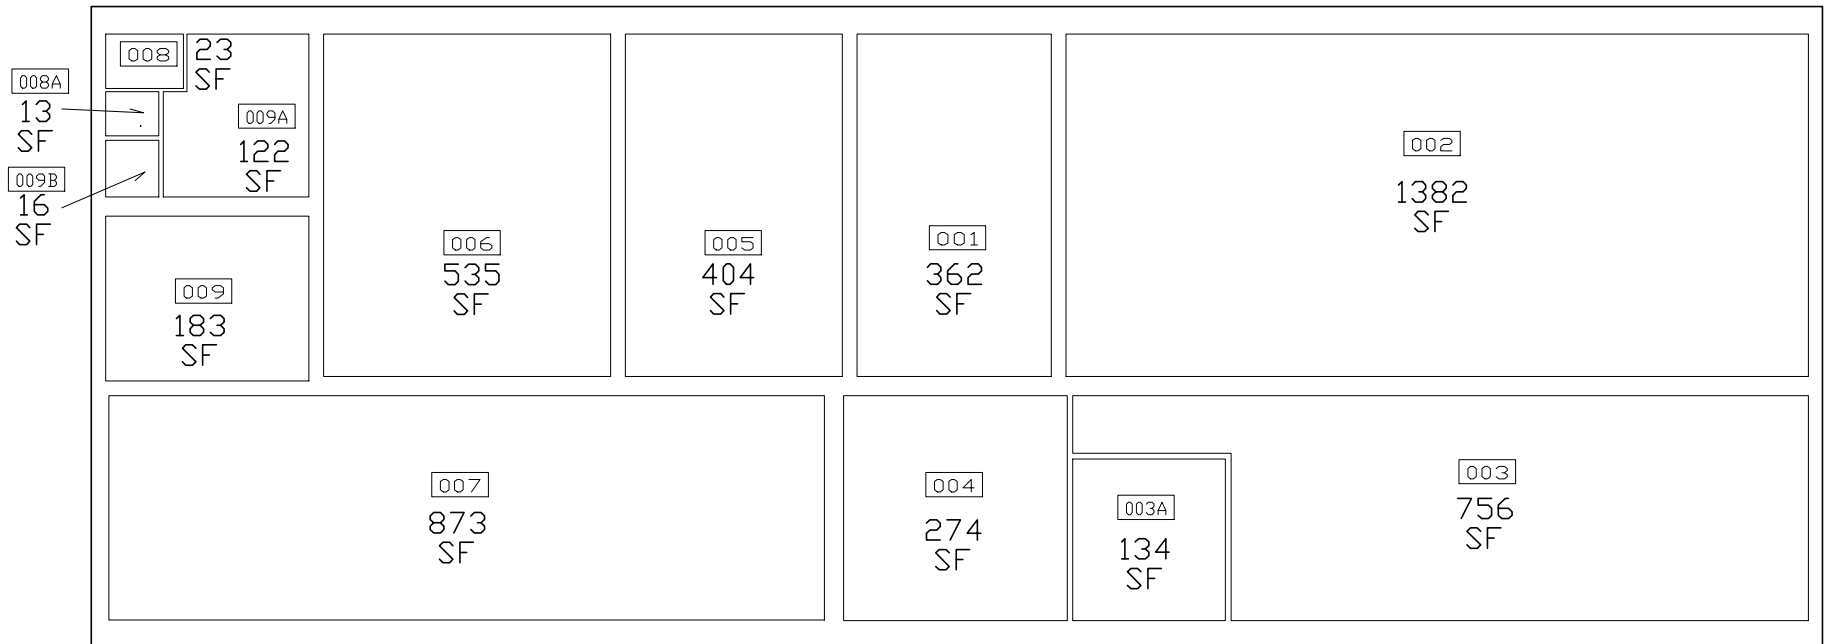
FIGURE 1

The Horse Farm Office was built in at least two phases around 1935, but is not considered to have any historical significance by NMSU's architecture department. However, the Horse Farm Office is an unusually large size for an adobe structure. It is currently unused, with the exception of the tack room which houses saddles and other tack equipment for the Horse Farm. The building covers 6,011 square feet and the exterior and interior walls of the Horse Farm Office are constructed of adobe. The exterior of the building is covered with stucco, which has cracked and fallen away in some areas as a result of moisture infiltration into the exterior. The roof is uninsulated and constructed of timber framing with corrugated metal sheeting. The

metal sheeting is not water tight and rain damage is visible on the interior timber framing and by erosion on the unfinished adobe interior walls.

The interior adobe walls are exhibiting damage at their bases where concrete facing was installed at the wall bases at a previous attempt to repair water damage. Concrete speeds up deterioration of adobe and is not recommended to be used in contact with adobe walls. The concrete facing has prevented the adobe walls from “breathing” when they absorb moisture and so moisture has to travel farther up the wall to evaporate into the atmosphere which damages the adobe. The damage is exacerbated where water pools on the building interior because of the leaking roof. Site drainage around the building is very poor and allows water to pool near the exterior walls in several locations which is then absorbed by the adobe walls which causes damage to the structure. The concrete floor of the building is in relatively good shape with some minor cracking.

The farm office has an interior office, restroom, kitchen/laboratory, and storage area with plastered or drywall interior walls. With the exception of the kitchen/laboratory which has its own separate roof structure within the larger building, all of the finished rooms show significant rain damage also. **Figure 1** shows a floor plan of the Horse Farm Office.

The Horse Farm Office is unusually large for an adobe structure and fits well with the cultural heritage of the College of Agriculture and the surrounding area. BHI consulted an adobe renovations expert who believed the building, while in need of extensive repair, is not beyond saving. Most of the deteriorated adobe is less than 4 inches deep in the walls and is repairable. The majority of the problems with the existing building are caused by poor site drainage which allows water to pool next to the adobe exterior walls and the leaking roof. Repairs to the walls have been attempted in the past by pouring a concrete facing at the base of the building's interior walls as an attempt to shore up the wall bases. However, the concrete has only exasperated these problems since moisture in the walls has to travel higher up the walls before it can escape to the atmosphere.

If NMSU chooses to renovate the Horse Farm Office, it is necessary that only traditional adobe construction methods and a qualified contractor be used to perform the work to ensure a long life for the structure. Using traditional materials will allow moisture that gets into the walls from the building foundation to escape to the atmosphere before it can travel up the walls and cause damage to the structure. Use of non-compatible building materials with adobe will speed up deterioration of the building. It will also be necessary to survey the site, locate an appropriate off-site storm water discharge location or retention ponding area, and construct swales around the site to allow for proper removal of storm water. These tasks would need to be done if the building is replaced with a new structure also.

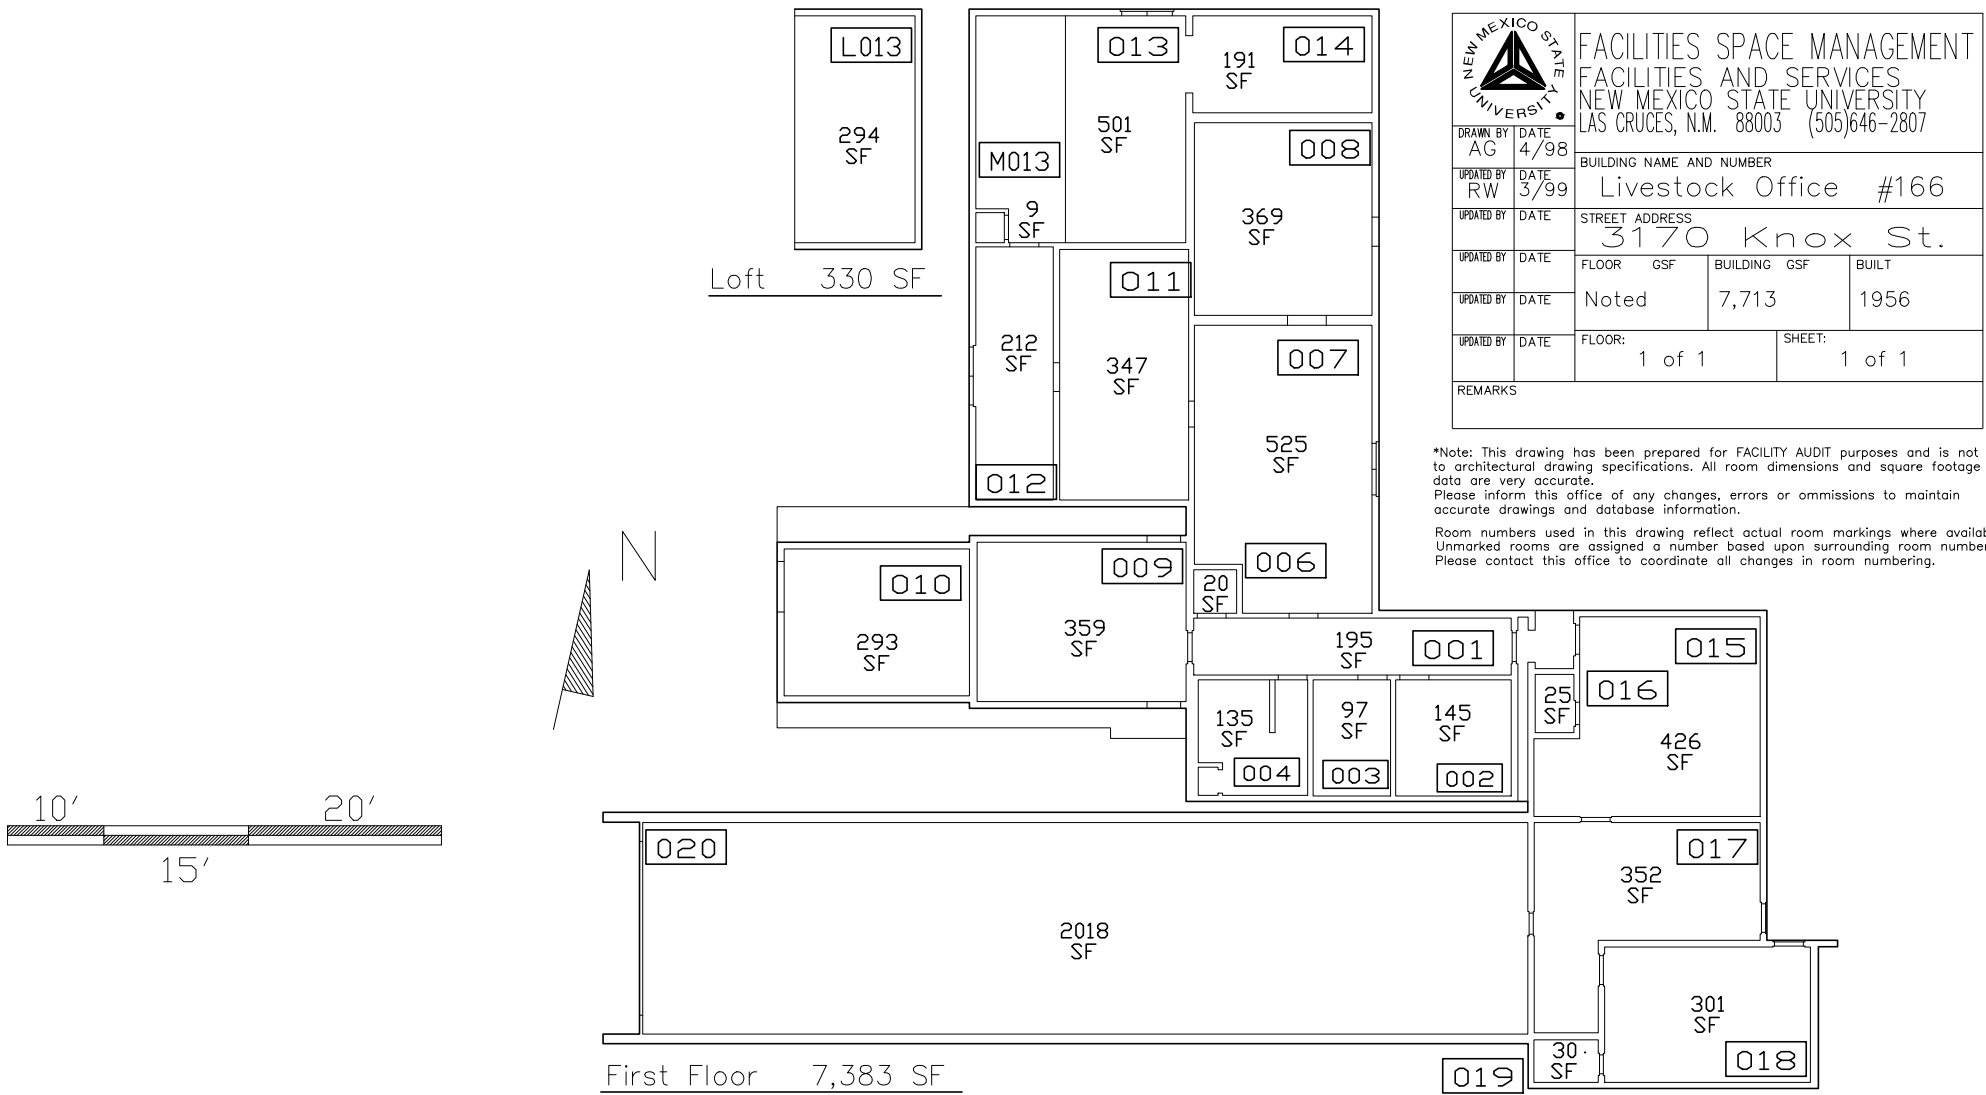
FIGURE 2

The Livestock Office was built in 1956, and is not considered to have any historical significance by NMSU’s architecture department. The Livestock Office covers 7,383 square feet and is actually two separate structures built adjacent to each other. The interior and exterior walls are constructed of CMU. The exterior is finished with stucco, and most of the interior walls are painted or plastered. The exterior stucco is in very poor shape and is peeling away.

There is evidence of settlement cracking throughout the building in both the interior and exterior walls. The roof of the 2,018 square foot dairy milking room is exhibiting large deflections due to water damage caused by a severely deteriorated roof. Water damage was observed throughout the remainder of the building, indicating that the entire roof is likely in similar shape. The building is known to have asbestos in some of the wall and ceiling materials and it is possible that there may be mold contamination in the building due to the prolonged water leaks in the roof. There was a fire at some point in the north part of the building, but the roof supporting members have since been reinforced with new lumber and appear structurally sound.

A custodial office and adjoining restroom were renovated within the last five years and appear watertight, though some evidence of minor settlement cracking on

interior, non-bearing walls is visible inside the renovated area. **Figure 2** shows a floor plan of the Livestock Office.

Rooms 009, 010, and 020 are a hay storage area, an unused chicken coop, and an unused dairy milking room respectively. These rooms were specifically designed and laid out for their original purposes. If the Agricultural Department doesn't intend to use them again as agricultural facilities, it is recommended that these rooms be demolished rather than renovated if NMSU decides to renovate this building rather than demolish or replace it.

The majority of the problems with the Livestock Office have arisen from the leaking roof. With a new roof, the structure could still be viable as a storage facility and office space but it is in need of extensive cleaning and updating. There is also some asbestos abatement that will need to take place before any renovations are completed.

The Livestock Office contains a hay storage room, an abandoned chicken coop and an abandoned dairy milking room (Rooms 009, 010 and 020). If NMSU chooses to renovate this building and does not intend to use those rooms for their original intended purposes, it is

recommended that these three rooms be demolished and the rest of the building renovated because they would be awkward spaces to try to re-purpose as classrooms, offices or storage spaces.

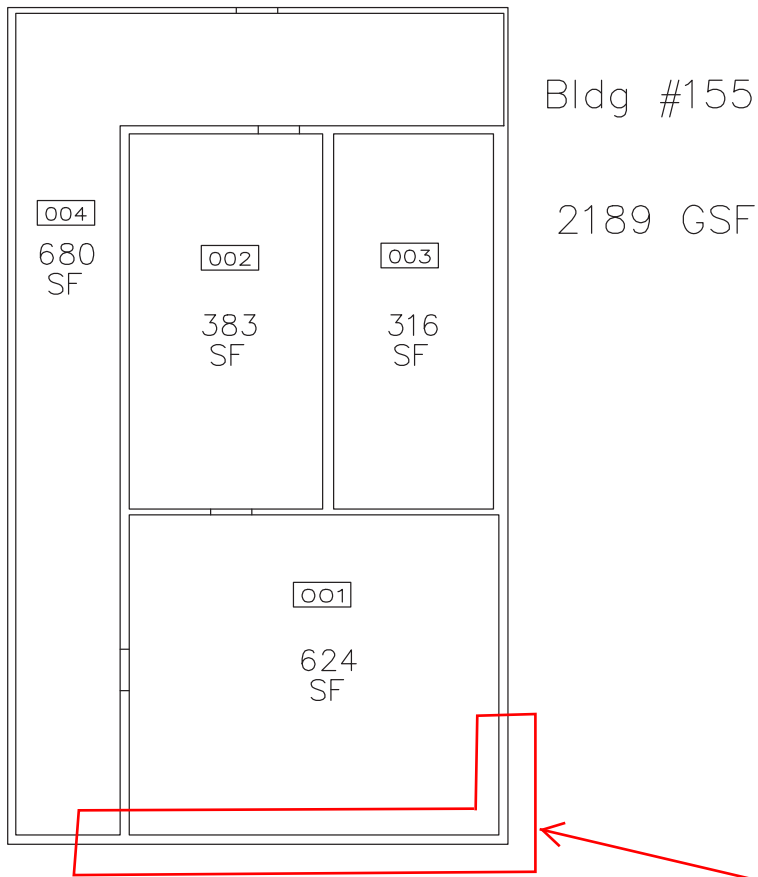
FIGURE 3

The Horticulture Shed was built in 1948 and is considered by NMSU to have historical significance to the campus. The Shed is a 2,189 square foot building with brick walls, cast-in-place concrete lintels and timber truss roof framing. The brick walls appear to be constructed on a continuous concrete stem wall foundation. The building has a raised wooden floor. The shed is uninsulated and has an unfinished interior. There is evidence of differential foundation settlement on the entire south wall, particularly pronounced in the southeast and southwest corners of the building. Although the settlement cracking is pronounced on the building exterior, there is no apparent distress to the interior building framing or floor. The settlement cracks have been visible for at least five years, but were not reported to have been widening since that time. There is also evidence of shear cracking at the corners of the four crawl space entrances spaced around the building exterior. **Figure 3** shows a floor plan of the Horticulture Shed.

The Horticulture Shed is adequate for its intended purpose. It is experiencing settlement on the south wall which should be stabilized if possible. It is likely the settlement is caused by a sublayer compacting due to a drop in the water table. BHI recommends a geotechnical investigation be completed near this wall to try to determine the cause of the settlement and an adequate bearing layer somewhere below the foundation. If an adequate bearing layer is found under the structure, helical piers can be installed along the wall experiencing settlement to transfer the bearing load from the soft layer to a deeper layer. The cracks can then be repaired to restore the aesthetic appearance of the building. The materials used to stabilize the wall will be buried and will not affect the historical appearance of the building.
